STATO DELLA CITTÀ DEL VATICANO

GOVERNATORATO  
DIREZIONE DEI MUSEI

It is with great joy that I am finally sending you the final report on the restoration of the Fountain of Saint Damaso.

## *Restoration Report*

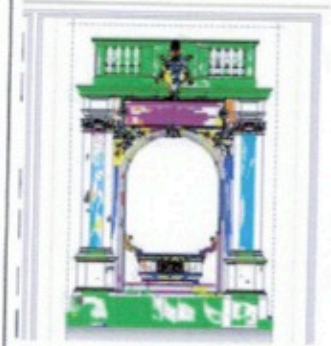
- All surfaces were completely washed with water and deposits and debris were removed.
- The restoration team identified and classified all unstable pieces of material which were becoming unattached to the fountain. They were then temporarily removed and cleaned prior to being replaced near the end of the restoration.

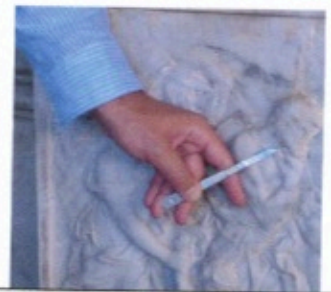
During the restoration and analysis of the monument, several issues arose concerning the coloring of the plaster on the wall and below the arch surrounding the fountain. Several cracks caused by the corrosion of metal elements were found at the bottom of the fountain.

It was necessary to proceed with stratigraphic and diagnostic investigations in order to define the correct enforcement procedures.

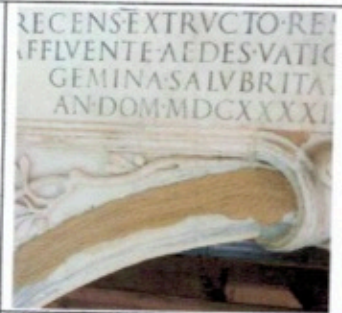
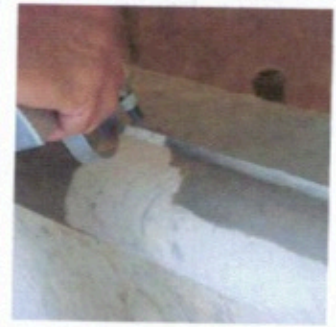
1. Cleaning of surfaces with water and nylon brushes.
2. Chemical cleaning of encrustations
3. Mechanical cleaning with air abrasives and natural abrasives (Garnet) for removing deposits and crusts of atmospheric particles.
4. Finishing

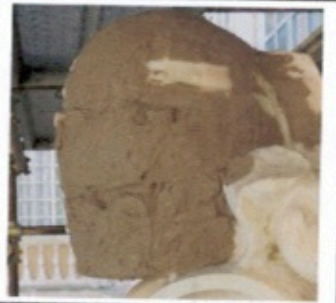
The discoloration was particularly evident with spots due to metal oxidation. In particular, copper salts had to be removed from the crown on the papal coat of arms. Metal oxidations were removed with the application of poultices comprised of sepiolite and 5% triammonium citrate.

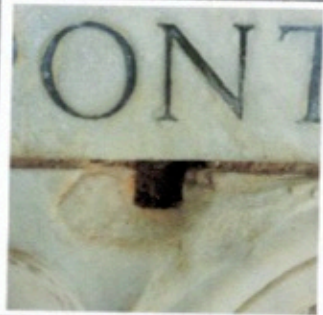
The treatment to stop the continuous corrosion of the iron pieces inserted in the marble was carried out with a chemical converter and with the application of Paraloid B72 5% and acetone.

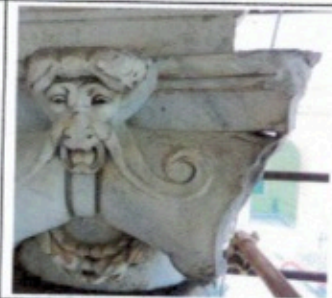
The consolidation of the areas affected by cracking, disintegration and degradation was done via applications of calcium hydroxide (CaLoSil) based micro-consolidants.
